Manhole Inspection Summary

Manhole # S27E__068MH

Insp Date: **9/19/07 11:22 AM**

Location Address: **205 FREMONT AVE**

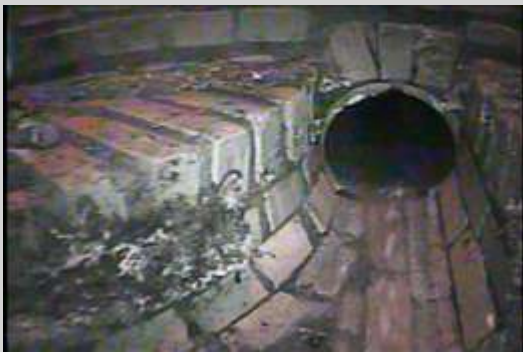
12 O'Clock Outflow

8 in. Circular Gravity Sewer
Pipe Out @ 12 O'Clock

Pipe Height: **8.4** (in.) Rod and Bar (Angled)
Pipe Material: **Clay** ☐ Pipe Lined
Invert Depth: **15.56** (ft.) Flow Characteristics: **Fast**
Deposits: ☒ None ☐ Mud ☐ Sludge ☐ Debris ☐ Grease
Silt Depth: (in.) Deposits Extent:
Infiltration: **None** Pipe Seal Cond: **Sound**

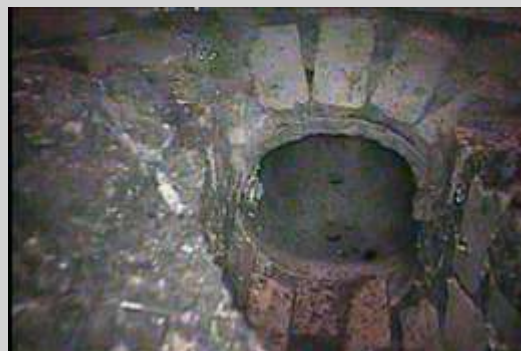
9 O'Clock Inflow

Pipe In @ 9 O'Clock

Drop In @ 9 O'Clock

Pipe Height: **8.4** (in.) Rod and Bar (Angled)

Infiltration: **None** Pipe Seal Cond: **Sound**

Drop Condition: **Open**
